1-3 Goodge Street was built in 1780 as part of a development project by Francis and William Goodge with the builder and architect Jacob Leroux. The inside of the building, which the architectural historian Dan Cruickshank described as 'an important historic asset', has been completely demolished.

Developers Dukelease won consent at appeal for its residential and retail development at the corner of Tottenham Court Road and Goodge Street designed by Rolfe Judd. The consent obtained earlier this year allowed for the demolition of the interior of the building leaving the facade.

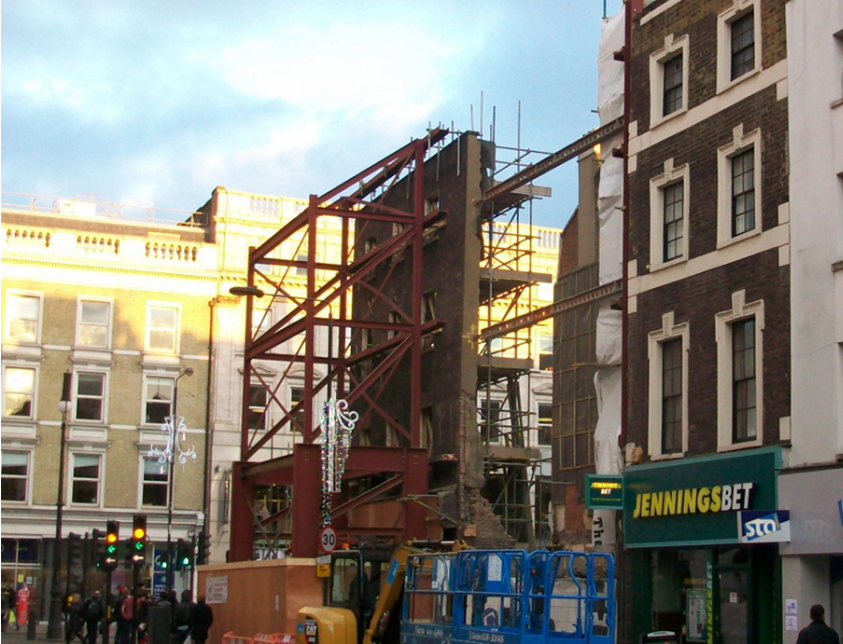
A girder is a support beam used in construction. This particular girder is strengthened by its I-beam cross section. Girder is actually a term used to describe the main horizontal support of a structure which supports smaller beams which in this case, hold up the brick facade.

The horizontal element of the I beam is called the flange. The vertical is the web. The flange resists the bending moment while the web resists shear forces. On the other hand, the cross-section has a reduced capacity in the transverse direction, and is inefficient in resisting torsion, for which hollow structural sections are often preferred.
